# Repairs Made - Follow-Up Stucco Inspection Report

495 Hickory Ridge Road  
Martinsville, VA 24112

Ian Hamre

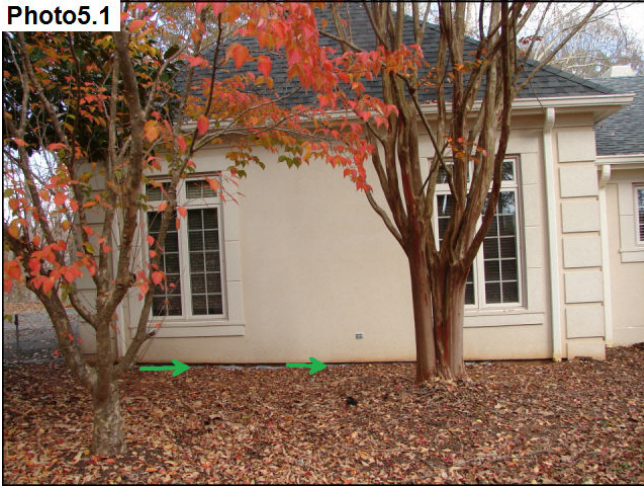
Photo5.1

Stucco termination is above grade and sealed. This was repaired after the initial first inspection as suggested.

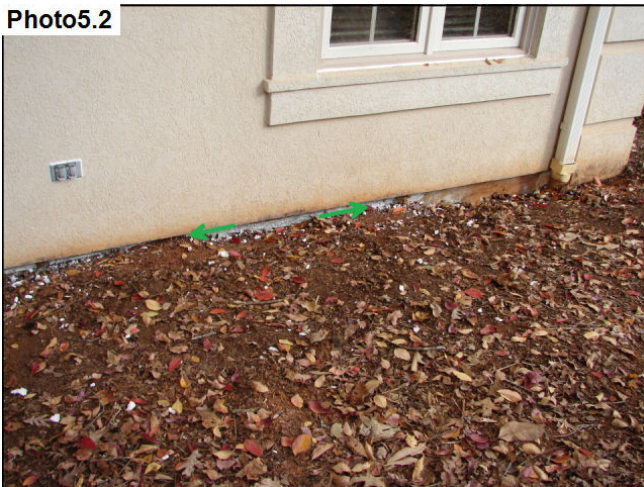
Photo5.2

Stucco termination is above grade and sealed. This was repaired after the initial first inspection as suggested.

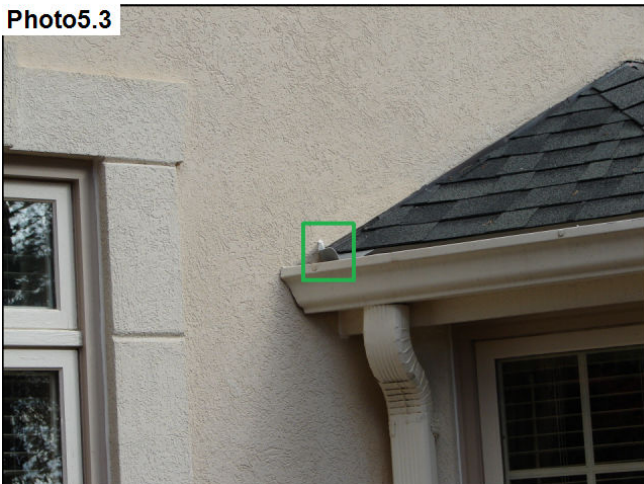
Photo5.3

Proper kickout flashing has been installed.

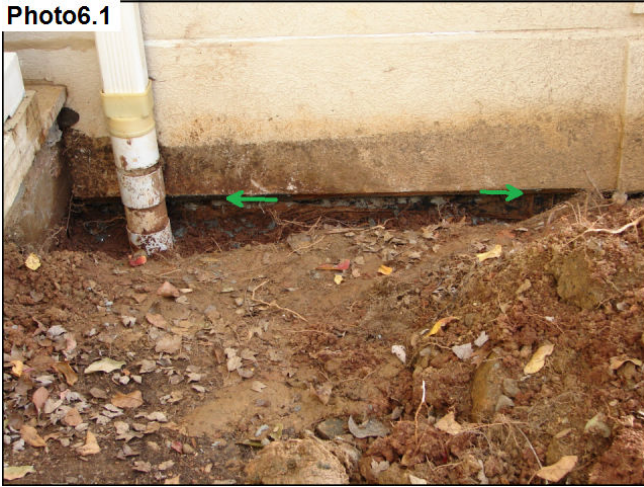
Photo6.1

Stucco termination is above grade and sealed. This was repaired after the initial first inspection as suggested.

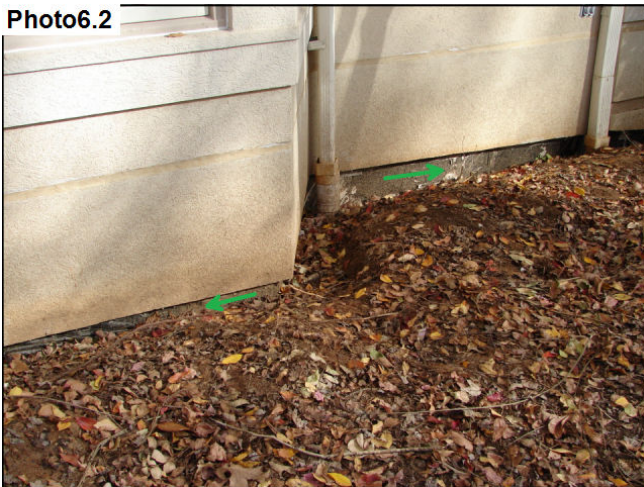
Photo6.2

Stucco termination is above grade and sealed. This was repaired after the initial first inspection as suggested.

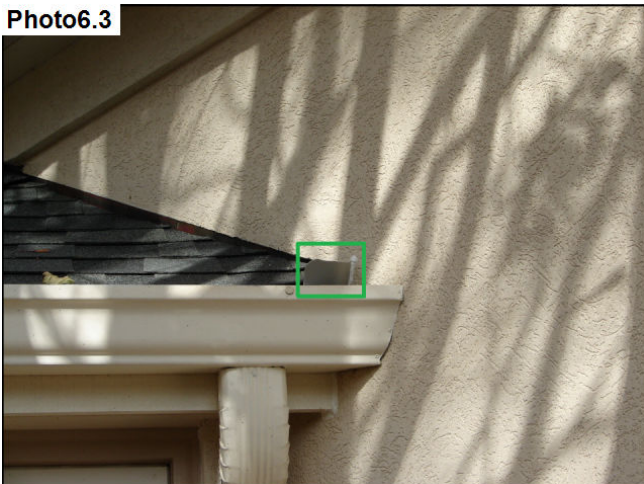
Photo6.3

Proper kickout flashing has been installed.

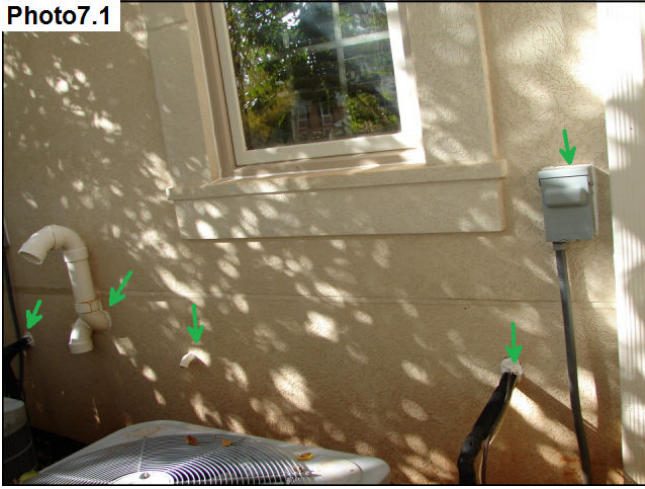
Photo7.1

Utility breaches have been caulked correctly.

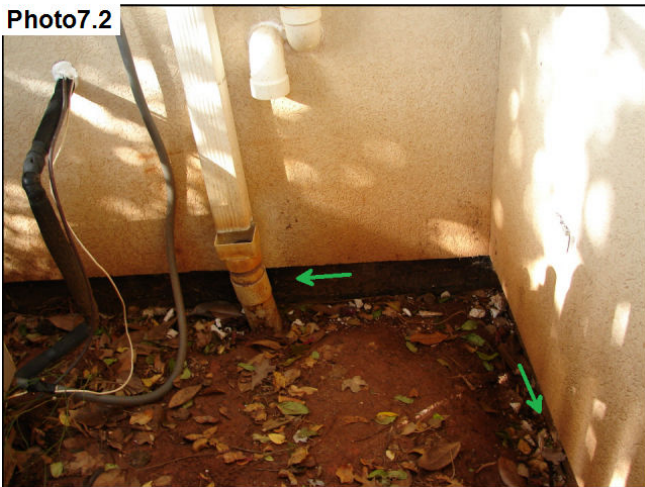
Photo7.2

Stucco termination is above grade and sealed. This was repaired after the initial first inspection as suggested.

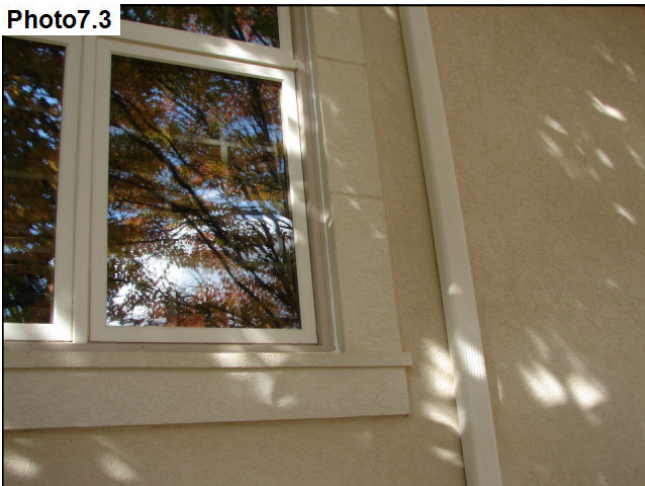
Photo7.3

All window caulk has been touched -up correctly.

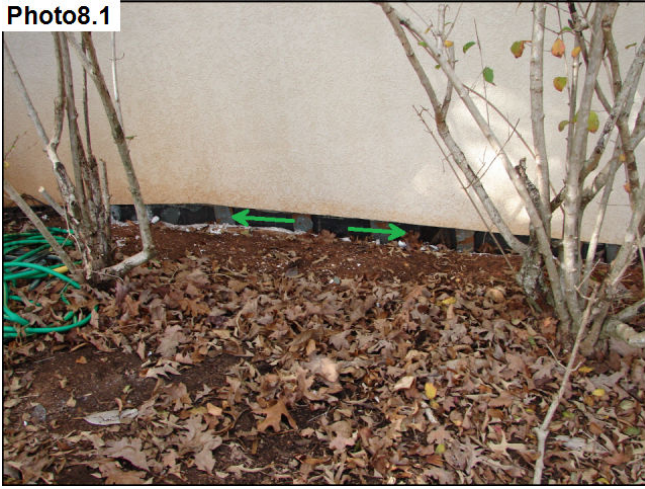
Photo8.1

Stucco termination is above grade and sealed. This was repaired after the initial first inspection as suggested.

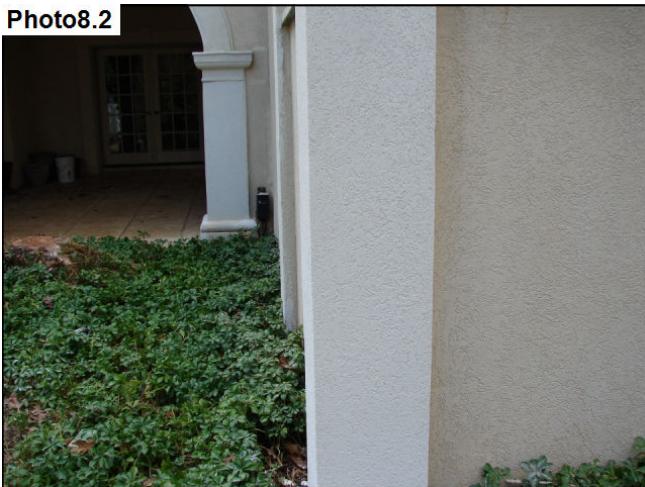
Photo8.2

Back elevation deck area has been re-skimmed with the proper stucco finish.

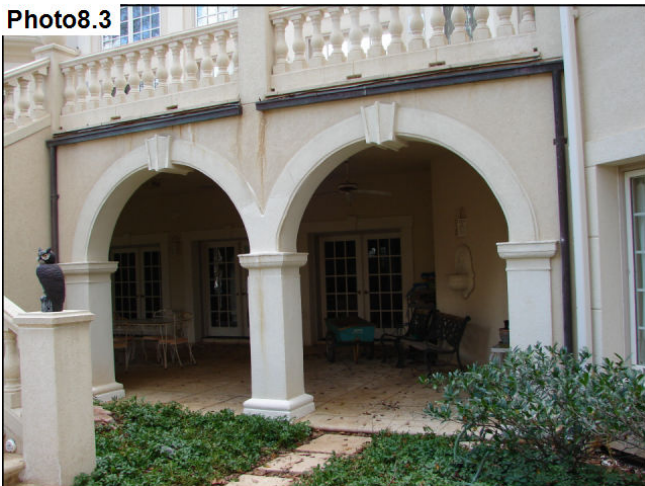
Photo8.3

Back elevation deck area has been re-skimmed with the proper stucco finish.

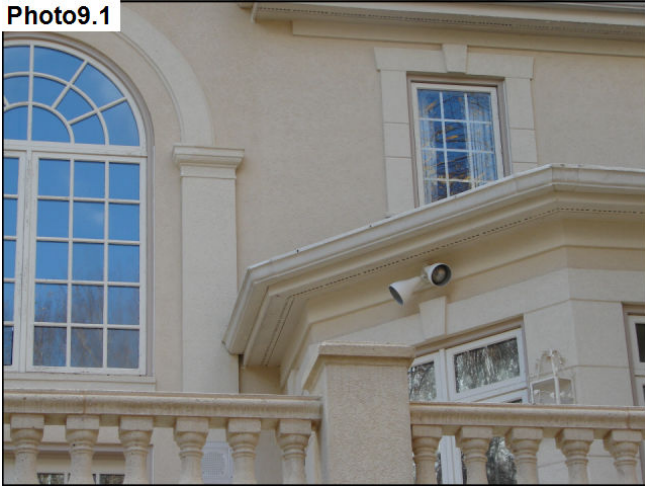
Photo9.1

Damaged stucco has been repaired correctly.

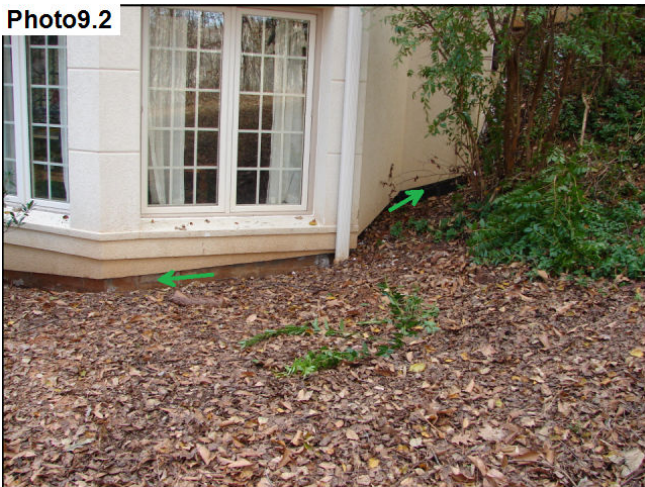
Photo9.2

Stucco termination is above grade and sealed. This was repaired after the initial first inspection as suggested.

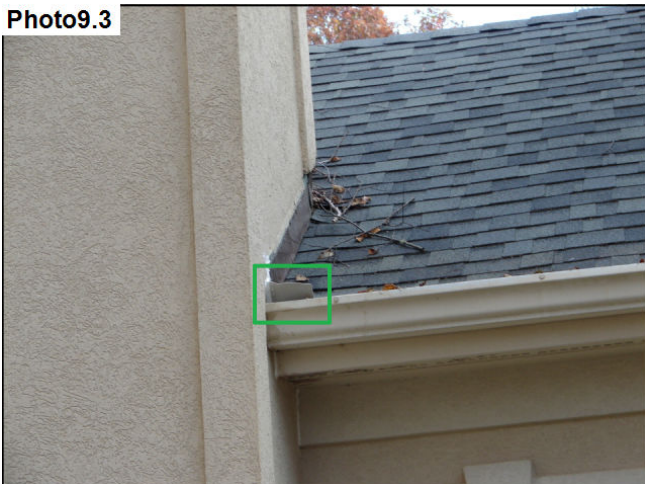
Photo9.3

Proper kickout flashing has been installed.

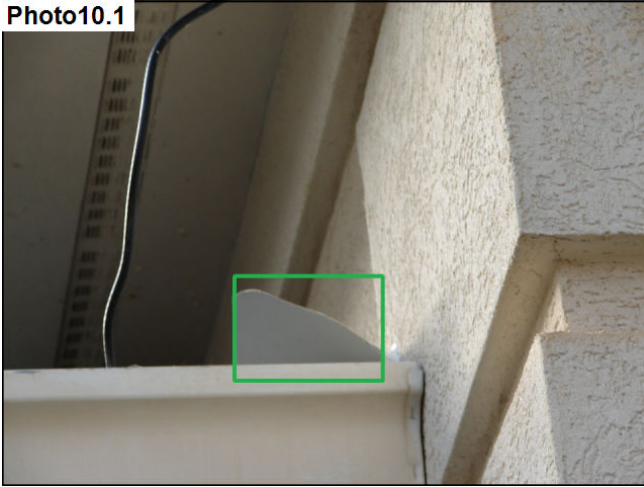
Photo10.1

Proper kickout flashing has been installed.

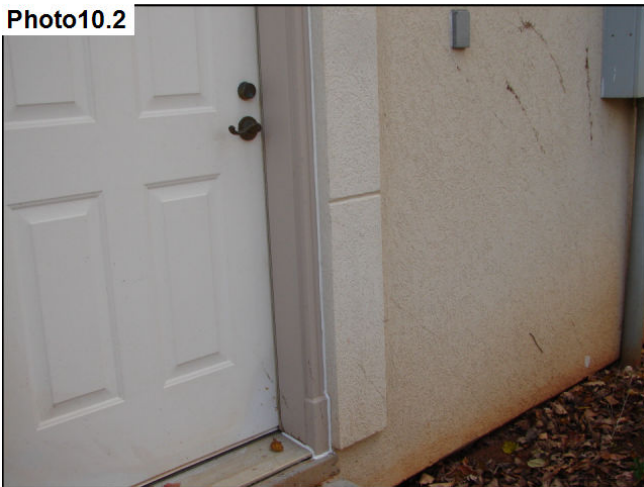
Photo10.2

Door frames have been caulked correctly.

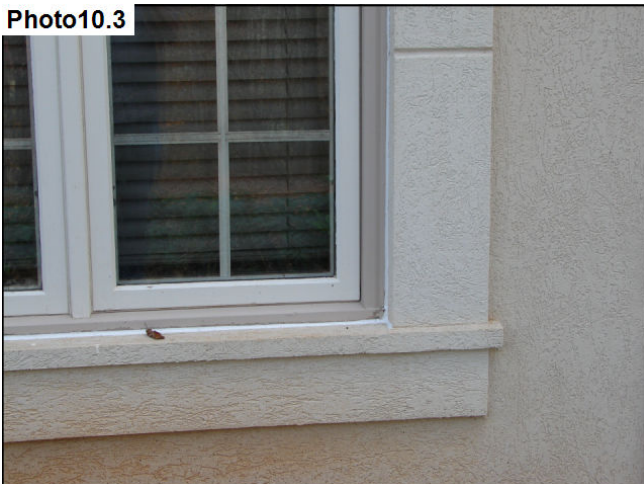
Photo10.3

Window frames have re-caulked.

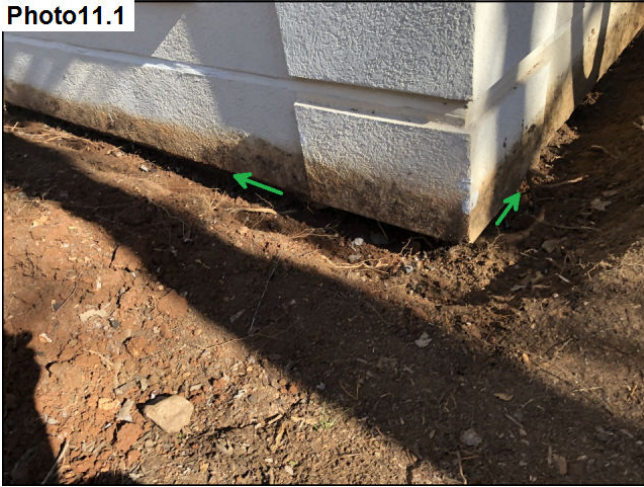
Photo11.1

Stucco termination is above grade and sealed. This was repaired after the initial first inspection as suggested.
